Manhole Inspection Summary

Manhole # S13CC1029MH

Location Address: **3942 REISTERSTOWN RD** Cross Street: **SHIRLEY AVE**

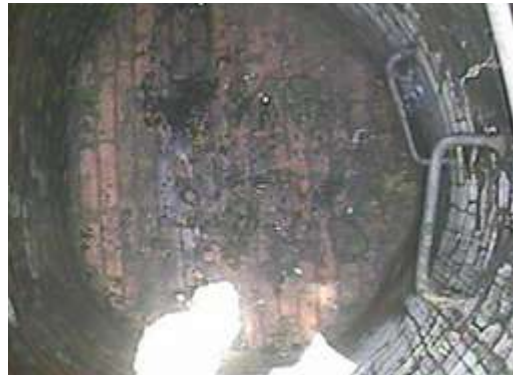
Top View

CHANNEL DEBRIS

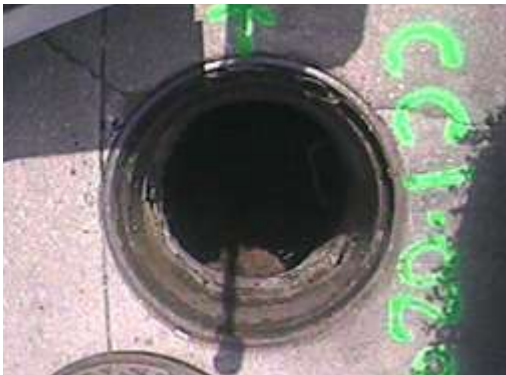
Top View

Frame Offset: **1** (in.) Condition: ☒ Sound ☐ Cracked ☐ Leaks

FRAME OFFSET

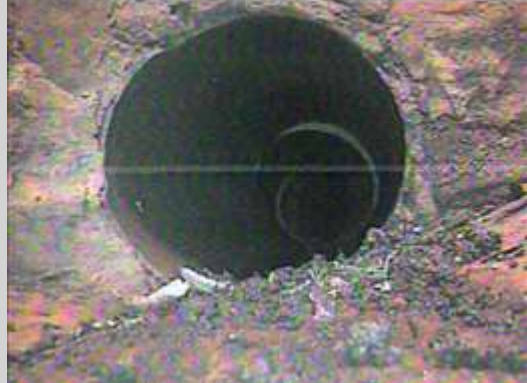
12 O'Clock Outflow

CHANNEL DEBRIS

Deposits: ☐ None ☐ Mud ☐ Sludge ☒ **Debris** ☐ Grease

Silt Depth: **0.5** (in.) Deposits Extent: **Light**

Infiltration: **None** Pipe Seal Cond: **Cracked**
